The value of multiple earthquake missions: the EEFIT L'Aquila Earthquake experience

T. Rossetto · D. D'Ayala · F. Gori · R. Persio · J. Han · V. Novelli ·
S. M. Wilkinson · D. Alexander · M. Hill · S. Stephens · S. Kontoe ·
G. Elia · E. Verrucci · A. Vicini · W. Shelley · R. Foulser-Piggott

Abstract In November 2012 EEFIT launched its first ever return mission to an earthquake affected site. The L'Aquila Earthquake site was chosen as this is a recent European event of interest to the UK and European earthquake engineering community. The main aims of this return mission were to document the earthquake recovery process and this paper presents an overview of the post-disaster emergency phase and transition to reconstruction in the Aquila area after the earthquake. It takes an earthquake engineering perspective, highlighting areas mainly of interest to the fields of structural/seismic engineering and reconstruction management. Within the paper, reference is made to published literature, but also to data collected in the field during the return mission that would not otherwise have been available.

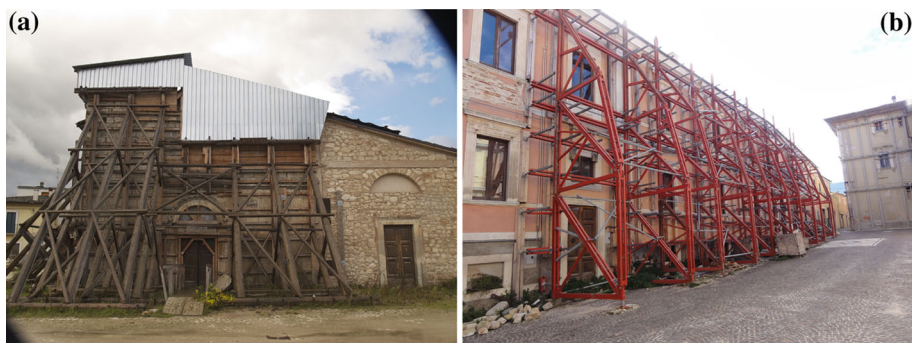
Fig. 1 Shoring system made of **a** wooden and **b** steel trusses used to prevent out of plane failure of masonry walls/panels

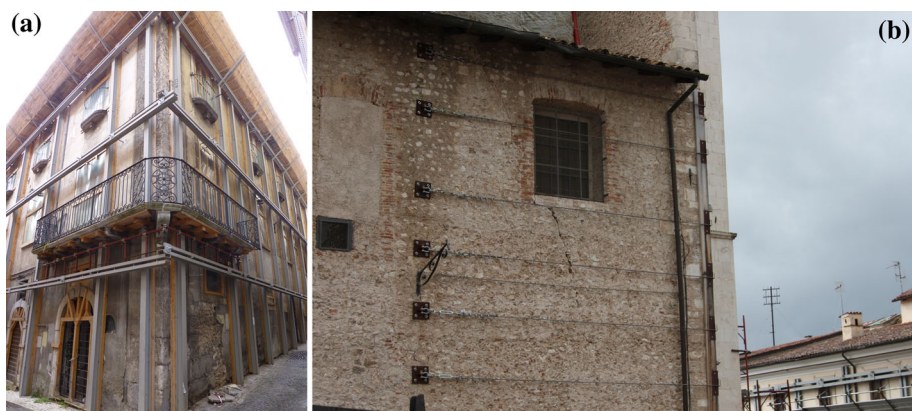
Fig. 2 Shoring system made of **a** steel frame to prevent combined mechanisms or overturning of the top floor and **b** steel cables, to prevent in plane failure and overturning of the corner

The most extensive post-earthquake deployment of temporary works in L'Aquila are shoring structures, since overturning of masonry facades (or parts thereof) is the most commonly observed failure mechanism (Modena et al. 2010). Safety interventions for this failure mode are seen to involve traditional wooden or steel truss systems (Fig. 1). The struts and ties form a buttress that prevents the overturning of the entire façade. The trusses are connected transversally and braced to prevent buckling and create a spatial truss. The possible effect of hammering between the facade and the shoring system, which may be triggered by aftershocks, is prevented by anchoring the top of the propping system to the wall, and the base to the foundation of the wall or to an independent system able of resisting the seismic load. A second system, made of vertical steel posts and horizontal ties is used extensively when floor structures have detached from facades and these show a crack pattern consistent with in-plane failure. Variations on this system comprise horizontally laid wooden planks, polyester straps or steel cables which wrap around the building with the aims of confining the masonry of the façade and of anchoring it to orthogonal walls (Fig. 2). The example in Fig. 2a is more appropriate when the connection between adjacent facades needs securing or when a combined mechanism causing out-of-plane failure of the façade and in-plane failure of its orthogonal walls is present. The steel cable system shown in Fig. 2b is suitable for

restoring the box behaviour of buildings with corner failures. In cases where the causes of failure are likely to comprise both in-plane and out-of-plane failures, a combination of the two shoring systems is required (Modena et al. 2010).

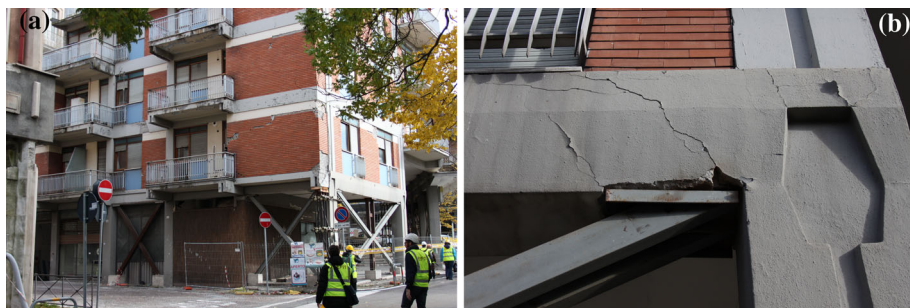
Fig. 4 Shoring of a Reinforced Concrete structure to prevent soft storey collapse. **a** Building elevation **b** shoring bearing against existing structure

of reinforced concrete structures that are stable in the temporary condition but require retrofit to return them to full service. It should also be noted that severely damaged reinforced concrete structures had either collapsed or been demolished at the time of the EEFIT return mission.

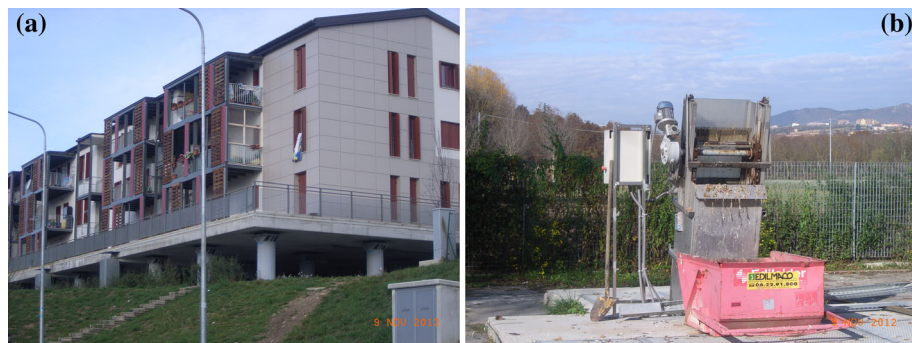
Fig. 8 Photograph of a C.A.S.E. building in the Bazzano site (a), and the inadequate sewage filtering site alongside the Aterno river (b)

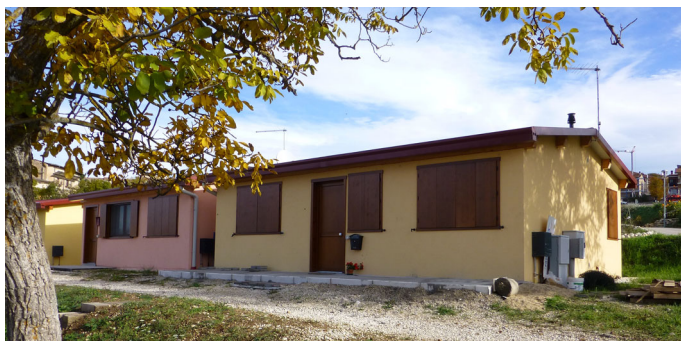
Fig. 9 Example of a MAP house in Fossa

maintenance problems (e.g. water infiltration) being observed at San Gregorio, where the quality of construction appears significantly worse than in Onna.

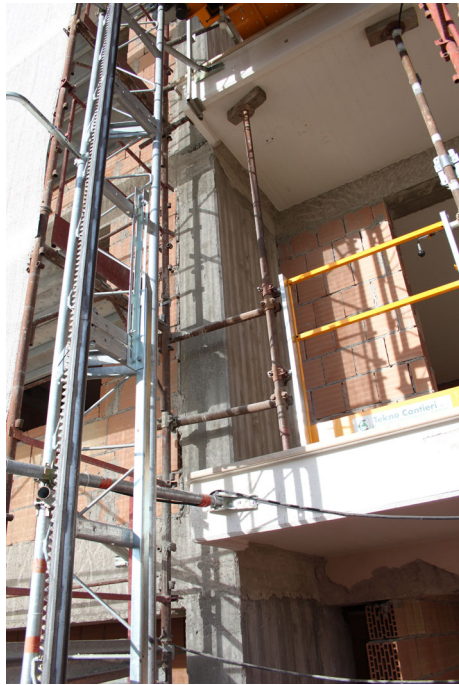
Fig. 10 Via Francia, Pettino.
Photograph of extended
perimeter column

Very similar repair and strengthening schemes were observed in the sites visited. In a typical retrofit observed in Via Francia, Pettino, perimeter columns were strengthened by increasing their depth from approximately 0.4–1.5 m over the full height of structure (see Fig. 10). Due to the cantilevering edge of the floor slabs, the face of the new column was flush with the slab edge. As the height to depth ratio of the column was approximately equal to two, the columns will behave as ‘ductile walls’—i.e. walls where the performance is governed by bending. Photographs provided by site staff suggest that longitudinal and transverse reinforcement provided in the column extensions were at close centres, at or

<100 mm, with longitudinal bars approximately 12–20 mm in diameter and transverse steel approximately 8–10 mm in diameter. Site staff informed the EEFIT team that the foundation ring and ground beams had also been improved as part of the works.

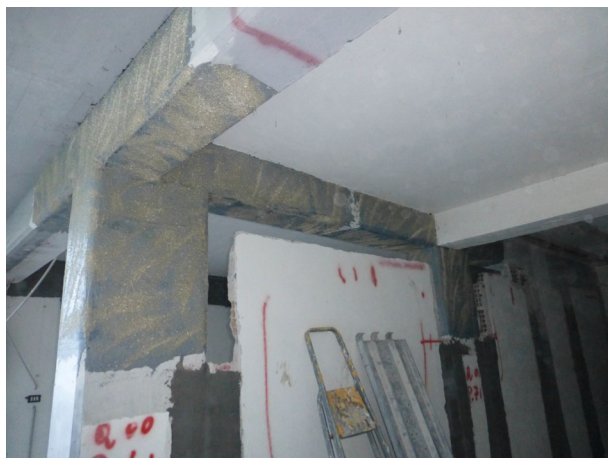
Fig. 11 Between Via Del Colle and Via di Strizzoli, Pettino. Beam/column joint strengthened with carbon fibre FRP. The image also shows that polypropylene mesh has been applied to connect the infill and columns

RC frame strengthening with FRP was almost universally adopted across retrofits and refurbishments visited, often in combination with the widening of columns or addition of shear walls. FRP was observed to be applied to beams, columns and beam-column connections to avoid brittle failure and improve ductility. FRP was also applied to beam-column connections to strengthen them against potential stresses imposed by infill panels (forming strut-like behavior in earthquakes). On apartment buildings, infill masonry panels were removed and replaced, with a polypropylene mesh fixed to beams and columns at edges to help restrain the masonry panel (Fig. 11). The aim of this modification was to prevent toppling of the panels, but not preclude damage.

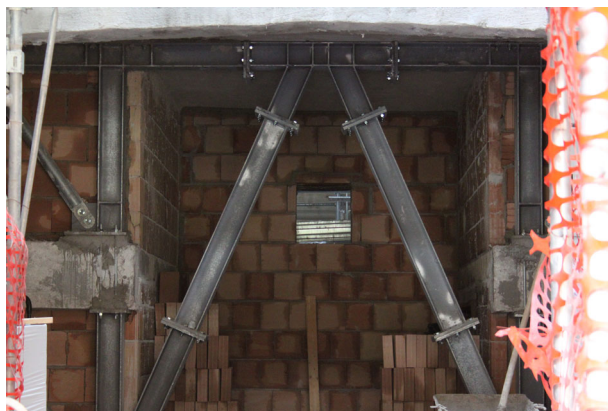
In a very few cases steel frames were observed to have been applied or base-isolation introduced. For example, a new steel frame was observed to be applied to the concrete frame of a five storey block of apartments in L’Aquila (see Fig. 12). Three identical apartment buildings in Pettino were demolished and replaced with new structures incorporating seismic isolation at basement level (Fig. 13a). The five storey reinforced concrete frames incorporate garage space on the ground floor, are infilled with clay bricks and are approximately 28 m × 14 m on plan. A grid of 6 × 4 concrete columns in the new basement support 24 “FIP Industriale” base isolators (Fig. 13b). The base isolators support a 400 mm thick RC slab and are in turn supported by 1.5 m high concrete columns that are a cruciform shape on plan and sit on a 600 mm thick raft foundation. It was noted on site that the cruciform section provides good biaxial stiffness while maintaining room for inspection and replacement of bearings if necessary. The basement retaining walls had been detailed to accommodate lateral displacement using a ‘dog-leg’ gutter detail, with also a vertical gap of approximately 15 cm at the slab edge.

Fig. 12 Condominio Vico Pienze, L'Aquila. Retrofitted steelwork observed from the site boundary

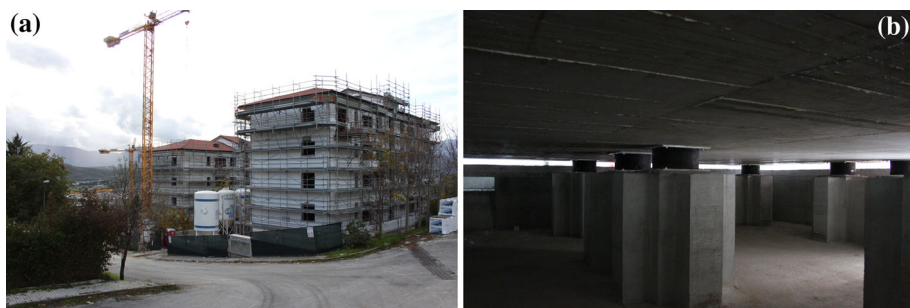
Fig. 13 Via Francia, Pettino. **a** Photo of the base-isolated buildings and **b** view of the base isolators in the basement

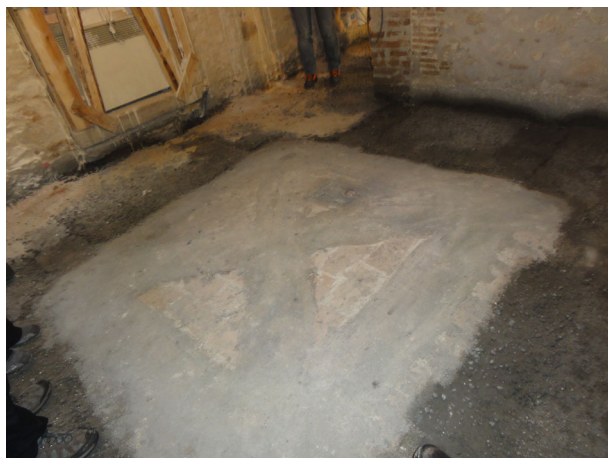
Fig. 14 reinforcement of a cross vault with strips of FRP laid at the extrados

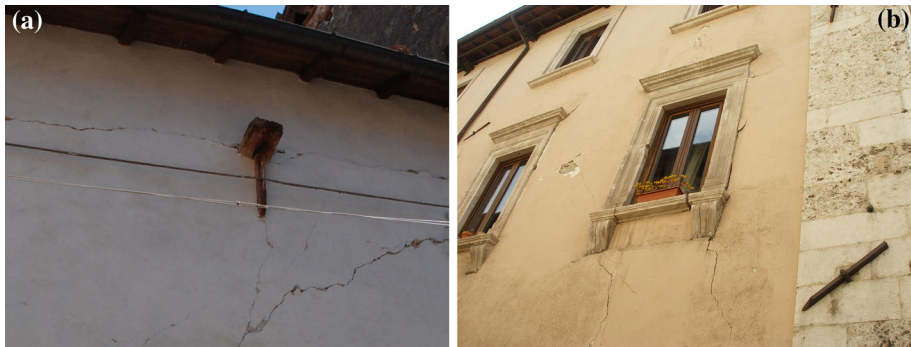
Fig. 15 Two examples of traditional reinforcement: **a** timber tie, **b** wrought iron cross tie inserted in a quoin

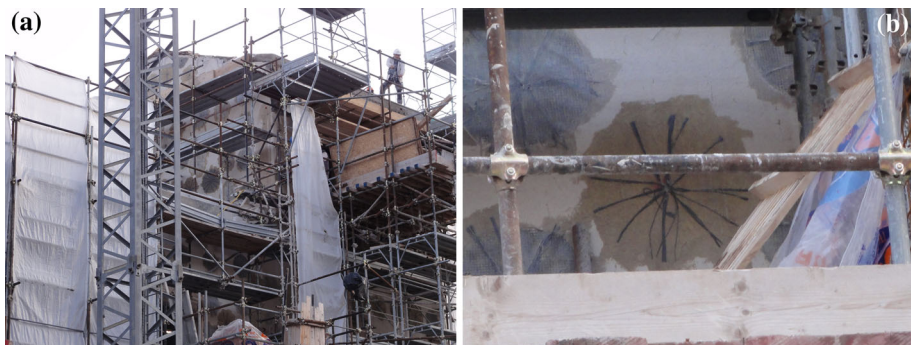
Fig. 16 Extensive use of reinforced coring with grouted injection with epoxy resins on the end wall of a five storey residential palace in the historic centre of L'Aquila

a vis [its] doubtful effectiveness, especially in the presence of walls with several wythes not well connected. In any case the durability of the strengthening element, whether of stainless steel, composite plastic materials or other material, should be ensured and the grouts used should be compatible with the original materials". Moreover it is advised that this type of intervention only has at best a local effect (Circolare n. 26/2010).
